Asian Journal of Chemistry; Vol. 28, No. 7 (2016), 1453-1462

## Corrosion Resistance of AA2036 and AA7075-T651 in Contaminated Acid Chloride Environments

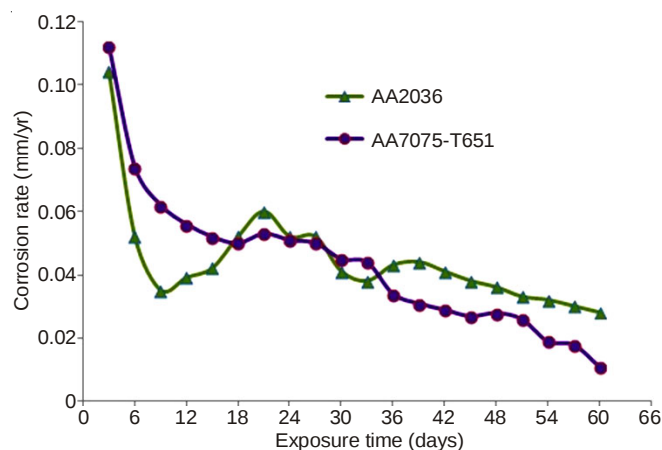
**Influence of exposure time on the corrosion rate and polarization resistance of AA2036 and AA7075-T651 in acid/saline-contaminated environments:** The corrosion resistance of the AA2036 and AA7075-T651 in NaCl solution increased with exposure time (Fig. 1). In Fig. 1, AA7075-T651 has better corrosion resistance than AA2036 when immersed in NaCl solution. However in Fig. 2, the two aluminium alloys have an increased corrosion rate with exposure time. Although in the  $\text{H}_2\text{SO}_4$  solution there seems to be lower corrosion rate for AA2036 alloy. While in HCl solution, the corrosion rate for the aluminium alloys decreased drastically along with exposure time indicating a lower corrosion rate in AA7075-

Fig. 1. Corrosion rate of AA2036 and AA7075-T651 in 3.5 % NaCl

**X-ray diffractometry (XRD) analysis of as-corroded aluminium alloys type AA2036 and AA7075-T651:** Figs. 11-15 show the XRD patterns of different corroded samples in various environments. In the solution contain 3.5 wt % NaCl (Fig. 11), the XRD results of the corroded AA2036 and AA7075-T651 showed varying level of Al. Low XRD spectra of Al found on corroded AA7075-T651 surface compared to the corroded AA2036, suggested the influenced of corrosion attack on the sample. Perhaps shift in the inter-planar spacing (peak) was caused by stress cracking observed on their SEM images. Thus in agreement with the corrosion rate results (Fig. 1).

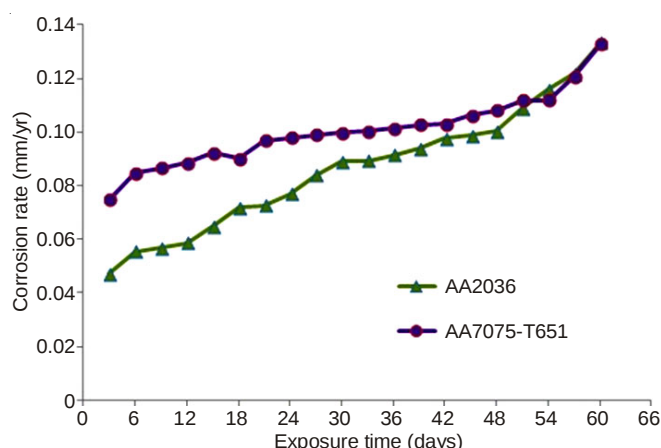
Fig. 2. Corrosion rate for AA2036 and AA7075-T651 in 0.5 M H<sub>2</sub>SO<sub>4</sub>

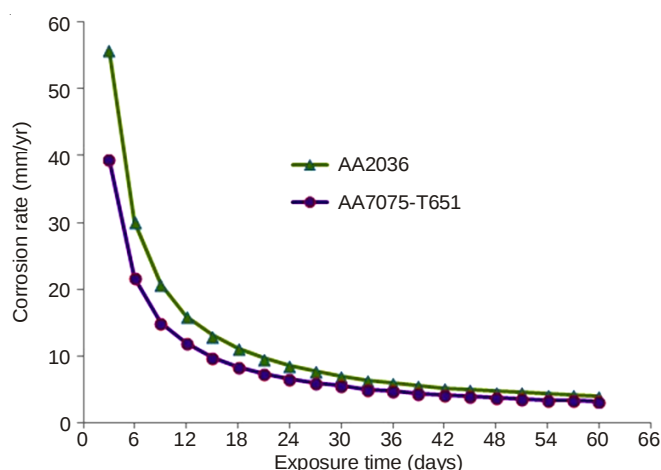
T651 than AA2036 (Fig. 3). This agreed with the work of Hijazi *et al.* [6] and David [10]. Similar trend was observed for the contaminated H<sub>2</sub>SO<sub>4</sub>-chloride (Fig. 4) and HCl-chloride environment (Fig. 5). The corrosion resistance of the AA2036 can be said to be higher than that of AA7075-T651 throughout the exposure time considered.

Fig. 3. Corrosion rate for AA2036 and AA7075-T651 in 0.5 M HCl

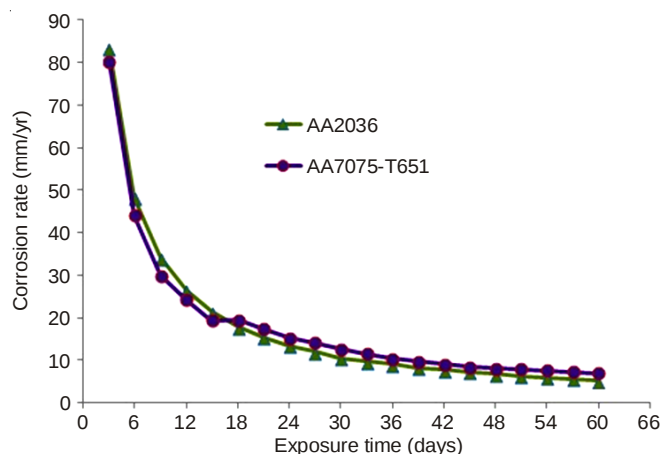
Fig. 4. Corrosion rate for AA2036 and AA7075-T651 in a contaminated 0.5 M H<sub>2</sub>SO<sub>4</sub> with 3.5 % NaCl solution

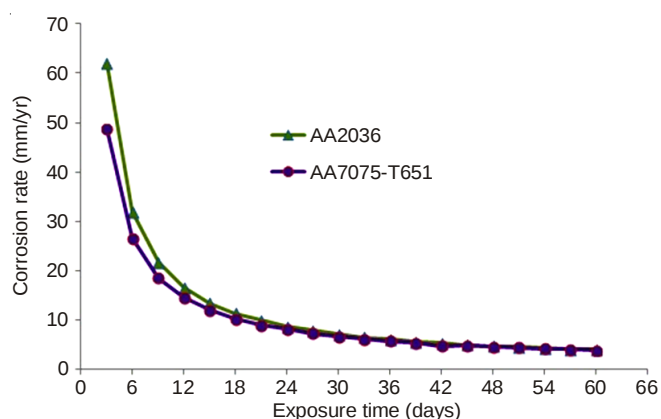
Fig. 5. Corrosion rate for AA2036 and AA7075-T651 in a contaminated 0.5 M HCl with 3.5 % NaCl solution

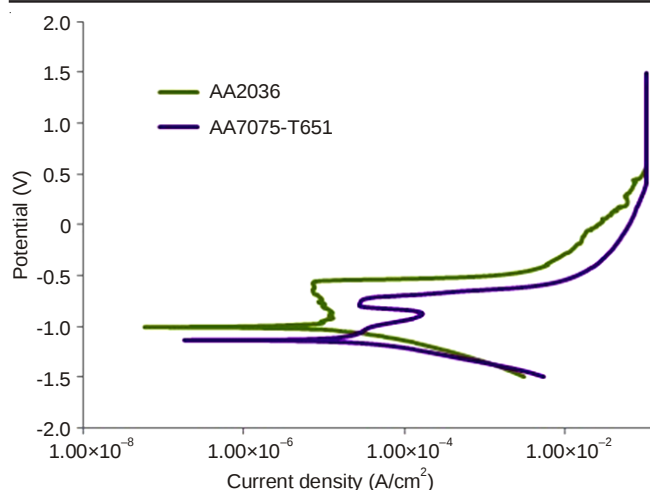
potential than AA7075-T651 (Fig. 6) indicating a 59 % (over 2 times) improvement. Similarly, in H<sub>2</sub>SO<sub>4</sub> solution, AA2036 alloy still exhibits the lowest corrosion rate, indicating higher protection against corrosion attack (Fig. 7). But in HCl solution, the corrosion rate of AA2036 became higher than AA7075-T651 (Fig. 8) with polarization resistance of 39.565 and 56.323  $\Omega$ , respectively. In the contaminated acid-chloride solution, AA2036 alloy in H<sub>2</sub>SO<sub>4</sub> with NaCl have the lowest corrosion rate (Figs. 9 and 10). In particular AA2036 (Fig. 9) have 8.2585 mm/yr and AA7075-T651 (Fig. 10) with 16.706 mm/yr indicating a half value reduction. This analysis means that AA2036 alloy

Fig. 6. Tafel polarization curve for substrates AA2036 and AA7075-T651 in 3.5 % wt NaCl

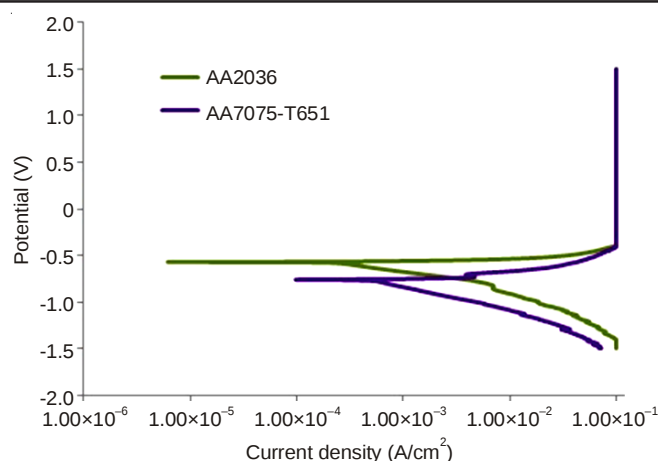
Fig. 9. Tafel polarization curve for substrates AA2036 and AA7075-T651 in 0.5 M H<sub>2</sub>SO<sub>4</sub> + 3.5 % wt NaCl

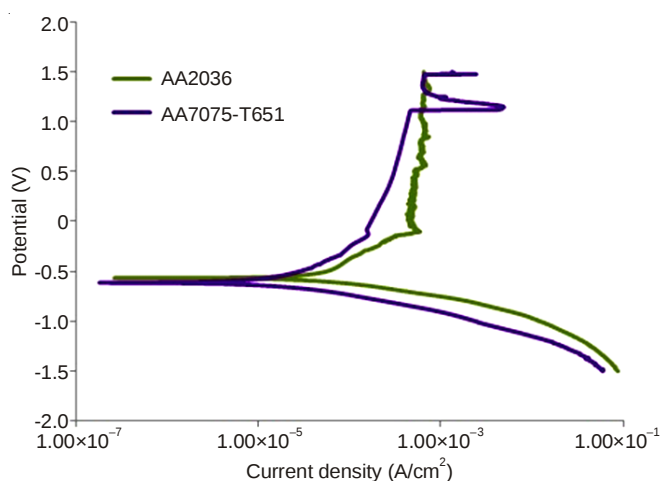
Fig. 7. Tafel polarization curve for substrates AA2036 and AA7075-T651 in 0.5 M H<sub>2</sub>SO<sub>4</sub>

Table-3 shows the data obtained from the polarization test, while Fig. 7 demonstrates the polarization curve for the

substrates in 0.5 M H<sub>2</sub>SO<sub>4</sub>. According to electrochemical principle the samples with the lowest corrosion current has the lower corrosion rate in active stage and low linear polarization, this cause the passive film to break down thereby leading to localized corrosion.

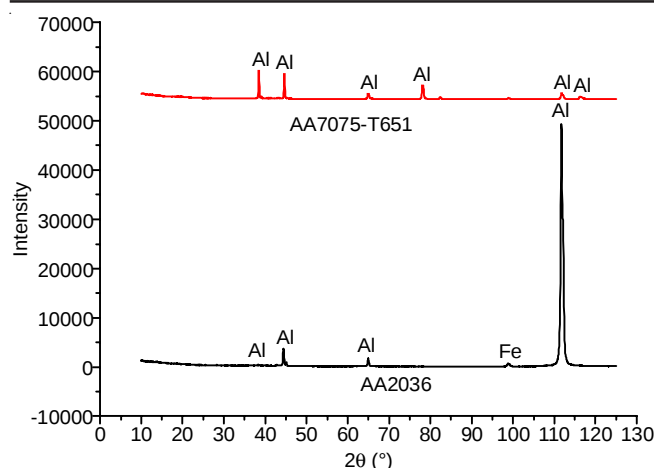
For the XRD spectrum of the corroded AA7xxx and AA2xxx samples, they are predominantly Al except for AA2xxx that has Fe in addition. However the spectra of

Fig. 11. XRD patterns of the corroded substrate samples in 3.5 % wt NaCl

AA7xxx was lower compared to AA2xxx, which has long peak at  $2\theta = 115^\circ$ . Thus, suggested that AA7xxx was highly attacked in the solution (Figs. 1-5 and Table-3). Overall, it is of no doubt that Cl<sup>-</sup> could not be found on both corroded AA2xxx and AA7xxx as a result of shifting in the peak or peak overlapping, as well as influence of corrosion.

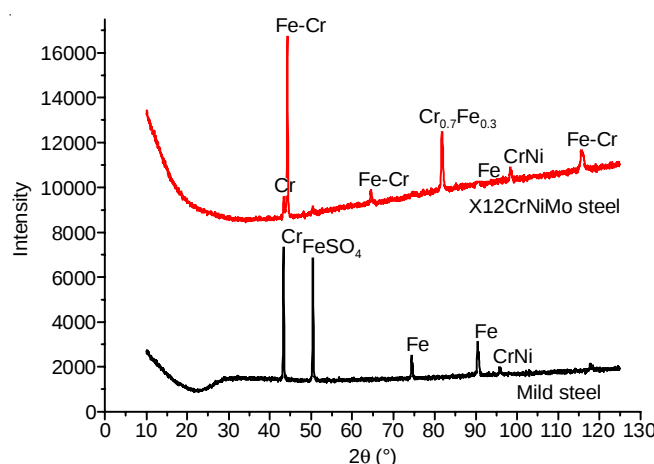
Fig. 12. XRD patterns of the corroded substrate samples in 0.5 M H<sub>2</sub>SO<sub>4</sub> solution

For corroded AA7xxx and AA2xxx series, their XRD spectrum was predominantly Al (fcc), although the XRD peak of AA2xxx were lower than AA7xxx spectra. Nevertheless, no sulphate ion was found on their surface. Surprisingly, a low Fe peak observed to be overlapping at  $2\theta = 120^\circ$  on AA7xxx. The reason could not be given and still unclear, perhaps could be due to the effect of corrosion on the elastic properties of the material. The XRD spectra of the samples immersed in 0.5 M H<sub>2</sub>SO<sub>4</sub> + NaCl were showed in Fig. 13. The corroded AA2xxx and AA7xxx comprised of Al (FCC structure), while H<sub>2</sub>SO<sub>4</sub> (H<sub>2</sub>O) with an unknown peak found at  $2\theta = 82^\circ$  detected on the corroded AA7xxx series. EDS revealed that some Fe, S, etc. is present on the corroded samples. Their omissions in the XRD spectra indicate that the amount may be too low to be detected. Thus, suggested that these minor elements might be underneath the corroded surfaces.

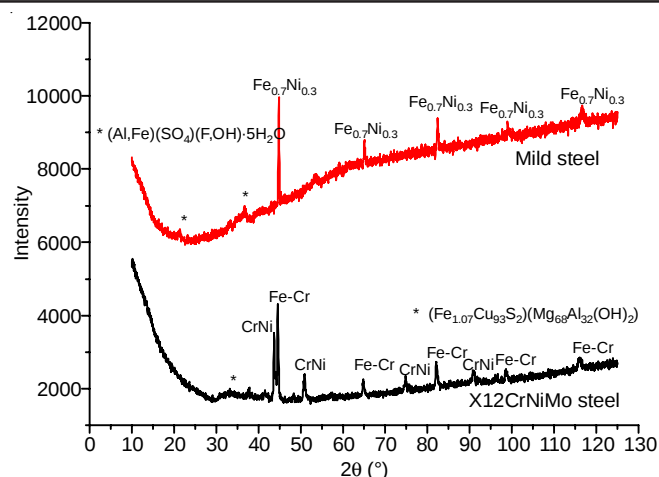
However, the presence of hydrated hydrogen sulphate revealed the rationale behind the worst performance of

Fig. 13. XRD patterns of the corroded substrate samples in 0.5 M H<sub>2</sub>SO<sub>4</sub> + NaCl solution

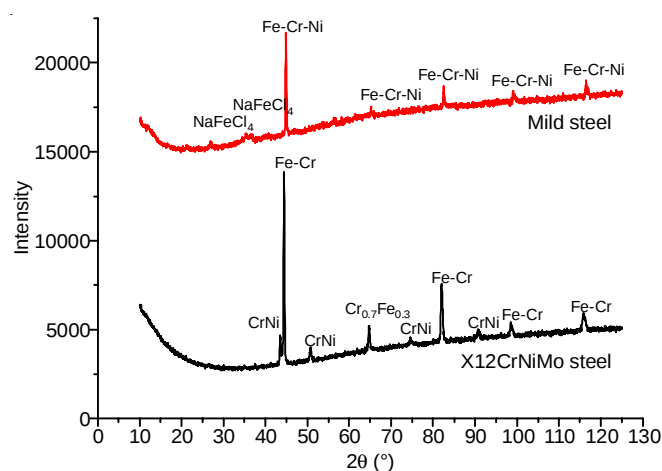
AA7xxx in the solution in comparison to others. Fig. 14 shows comparison of the corroded samples immersed in 0.5 M HCl + NaCl solution. The XRD pattern were similar for corroded AA7xxx and AA2xxx samples, indicating that the corroded surface comprised primarily Al. EDS scan revealed that Cl was present on the corroded samples. Its omission from the XRD spectra could be that the amount is too low to be detected.

Fig. 14. XRD patterns of the corroded substrate samples in 0.5 M HCl+ NaCl solution

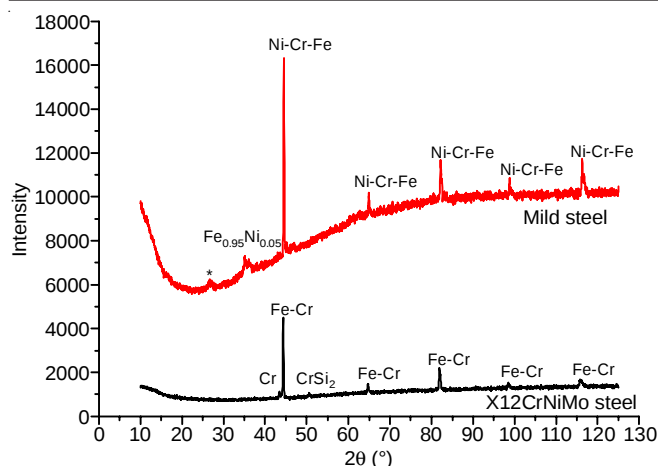
Fig. 15 shows the XRD patterns of the corroded samples immersed in HCl environment. Different phases were found on their corroded samples as expected, due to their physical properties, production, elemental composition and their percentage. All corroded sample in HCl had a highest peak at  $50^\circ$  to  $40^\circ$  (although the phases were different). The corroded AA7xxx revealed the presence of Al only, but their XRD peaks were extremely low as a result of corrosion effect. The presence of chlorine could not be found on the XRD as results of its amount. For corroded AA2xxx samples, the XRD spectrum was significantly different to AA7xxx sample. There were large Cu peak at  $2\theta = 44^\circ$ , followed by Cu<sub>2</sub>O peak at  $2\theta = 50^\circ$ . In addition, three different phases were found: MgO0.6, MgO0.6, Cu and Al, which is expected. The formation of CuO could be due to affinity of Cu to oxygen caused by oxidation. This is in agreement with EDS results. Also, there was a higher

background between  $2\theta = 10\text{-}35^\circ$ . This could be due to bleaching effect of chlorine on the corroded samples, as well as the effect of residual stress (strain).

Overall, the results showed that the degradation behaviour of AA2xxx is worst compare to AA7xxx in HCl solution. The emergence of complex compound of AA2xxx suggested the reason behind the worst performance.

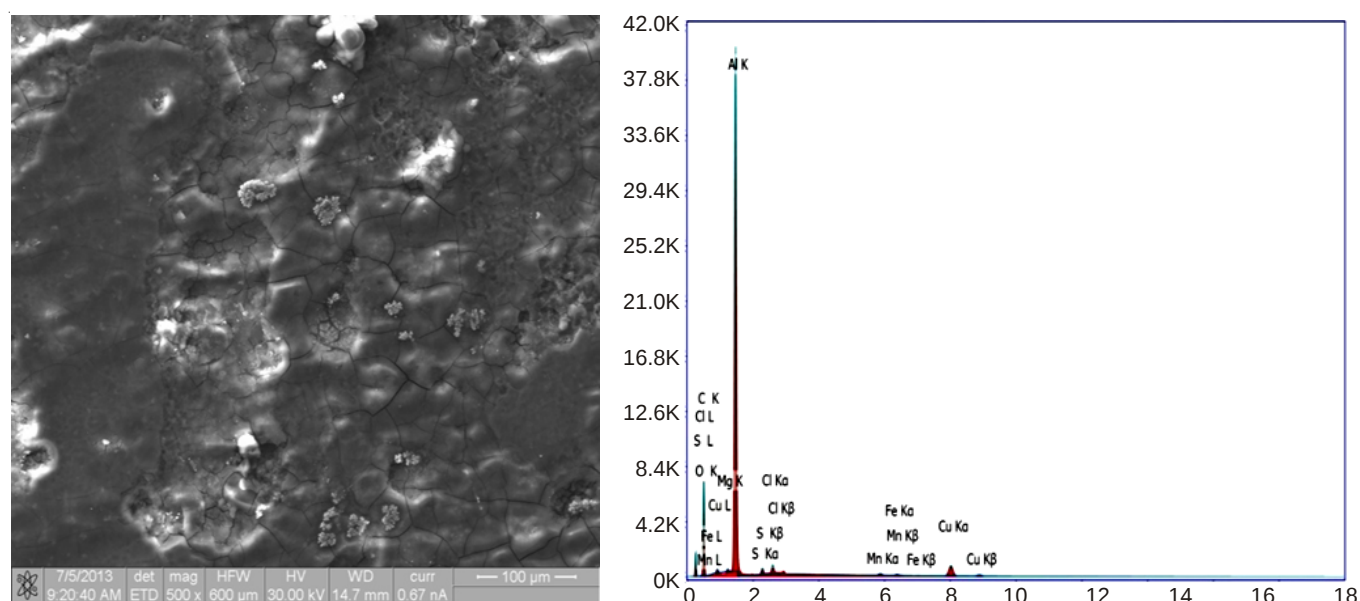
The microrgraphs reveals formation of widely salts precipitates and pits formation after 60 days of exposure of AA2036 in chloride media (Fig. 16). The grain boundary were not pronounced. The presence of chloride ion has a significant effect on the stability of the passive layer. EDS analysis reveals that the film formed on AA2036 is composed of C, O, Cl, S, Mn.

Fig. 16. SEM/EDS spectra of corroded AA2036 in 3.5 % wt NaCl solution

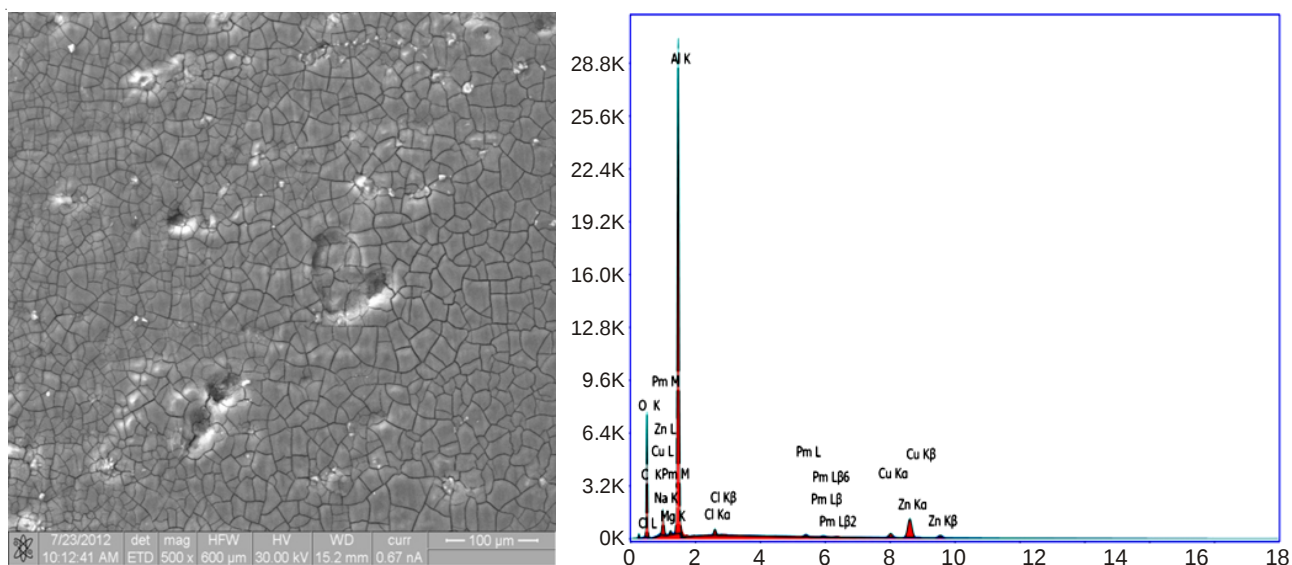
Fig. 17 shows the SEM micrograph of AA7075T-651, the micrograph reveals formation of salts precipitates in the pits after 60 days of exposure. The grain boundary were pronounced. EDS analysis reveals the chloride phases that were formed.

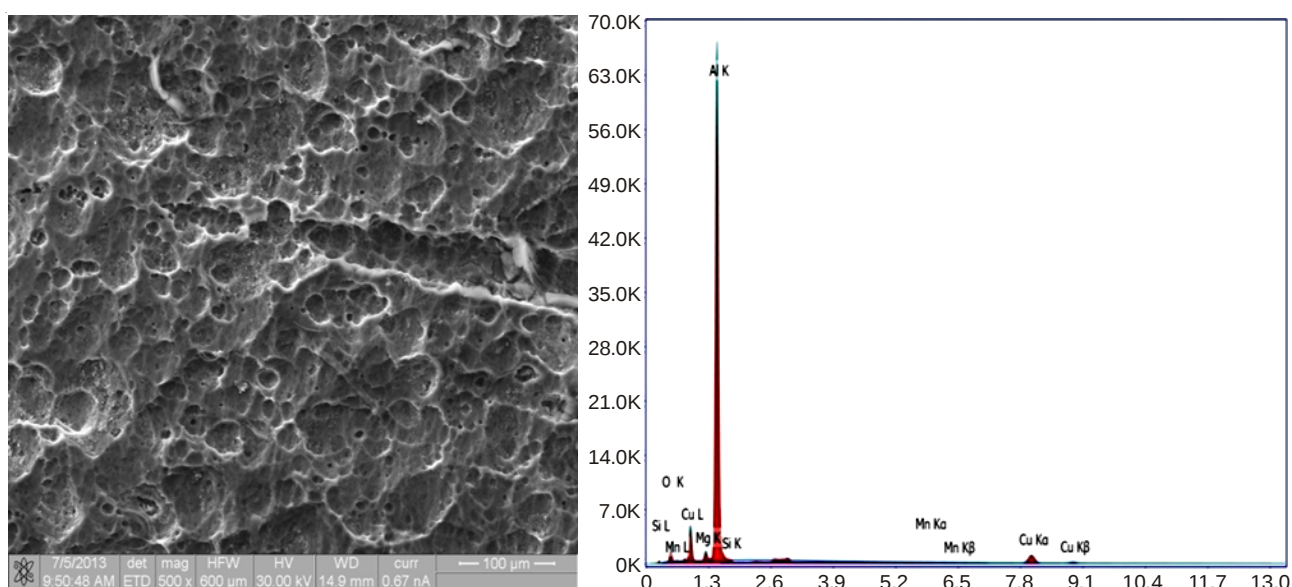
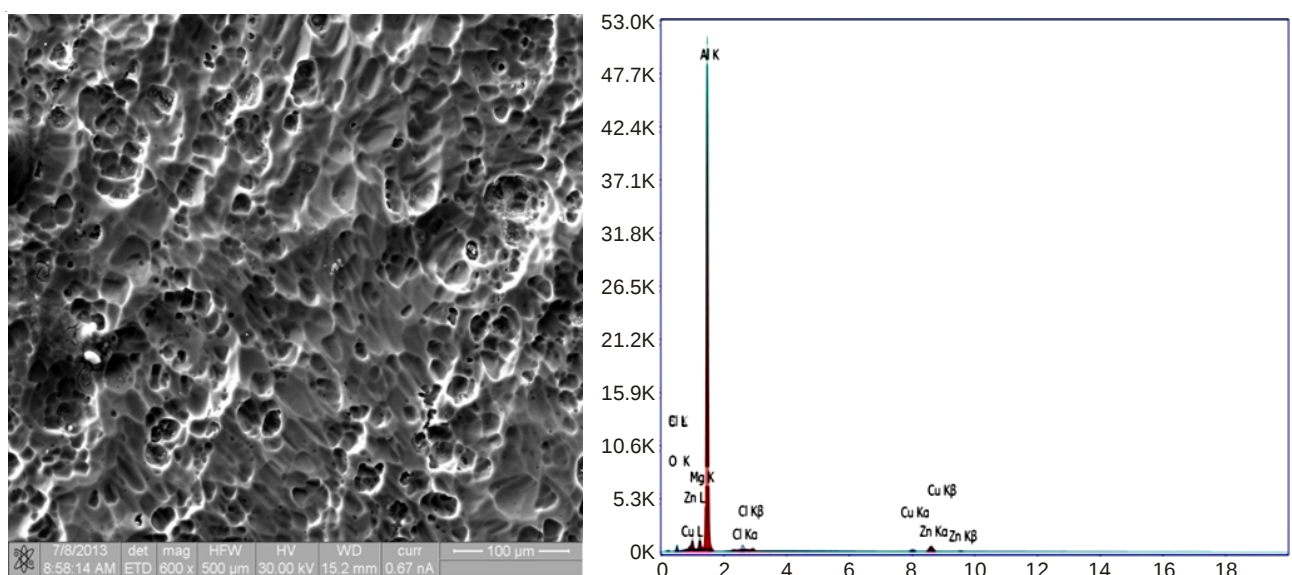
Figs. 18 and 19 show the SEM images of AA2023, AA7075-T651, respectively, morphological studies of the surfaces of the substrates in 0.5 M H<sub>2</sub>SO<sub>4</sub> was carried out using SEM after immersion in the test environment for 60 days at room temperature. AA2023 and AA7075-T651 surfaces were characterized with pronounced pits formation. On the interfacial surface, the sulphuric ion gets entry by penetrating through the oxide film and attack the metal. The evidence of uniform and pitting corrosion was found in the alloy similar to Szklarska-Smialowka [11].

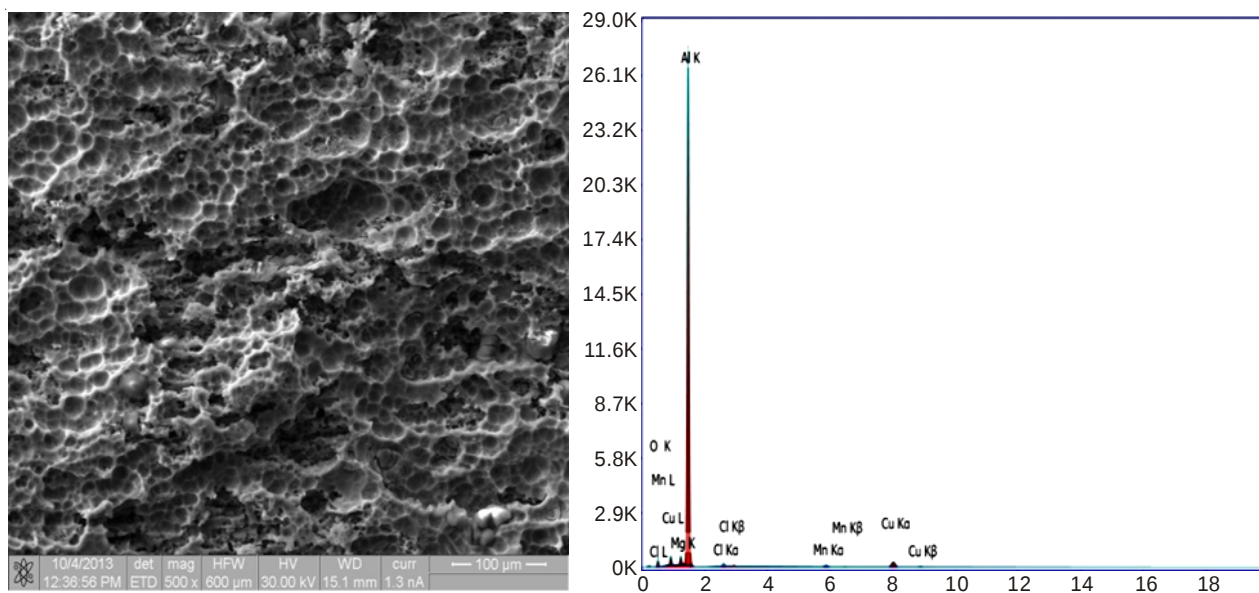
Fig. 20. SEM/EDS spectra of corroded AA2xxx in 0.5 M HCl solution

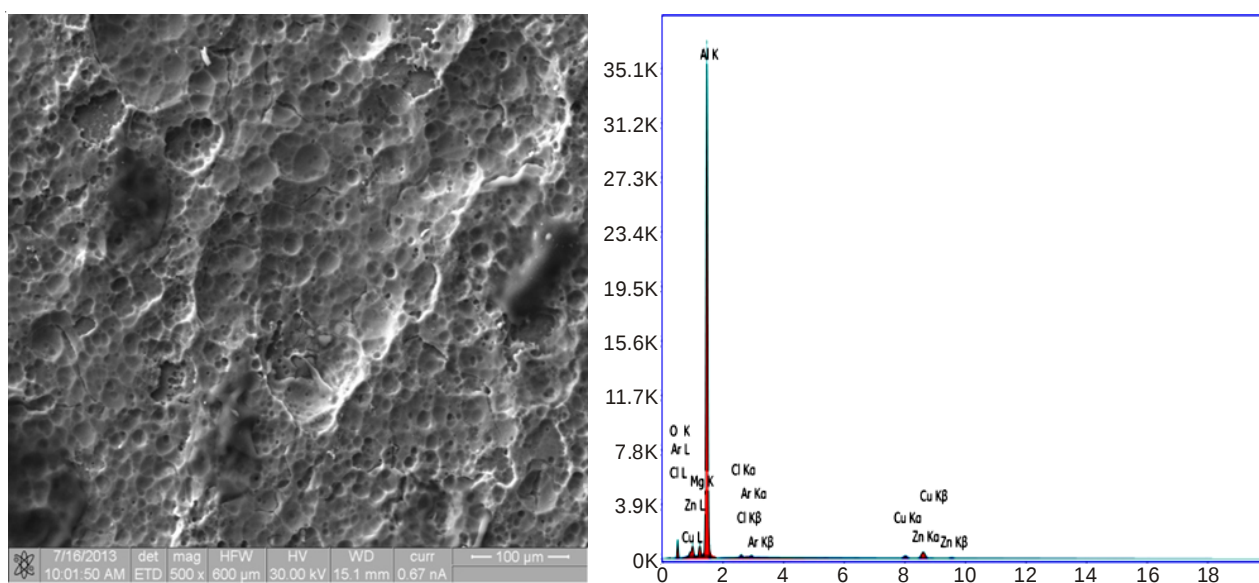
Fig. 21. SEM/EDS spectra of corroded AA7075-T651 in 0.5 M HCl solution

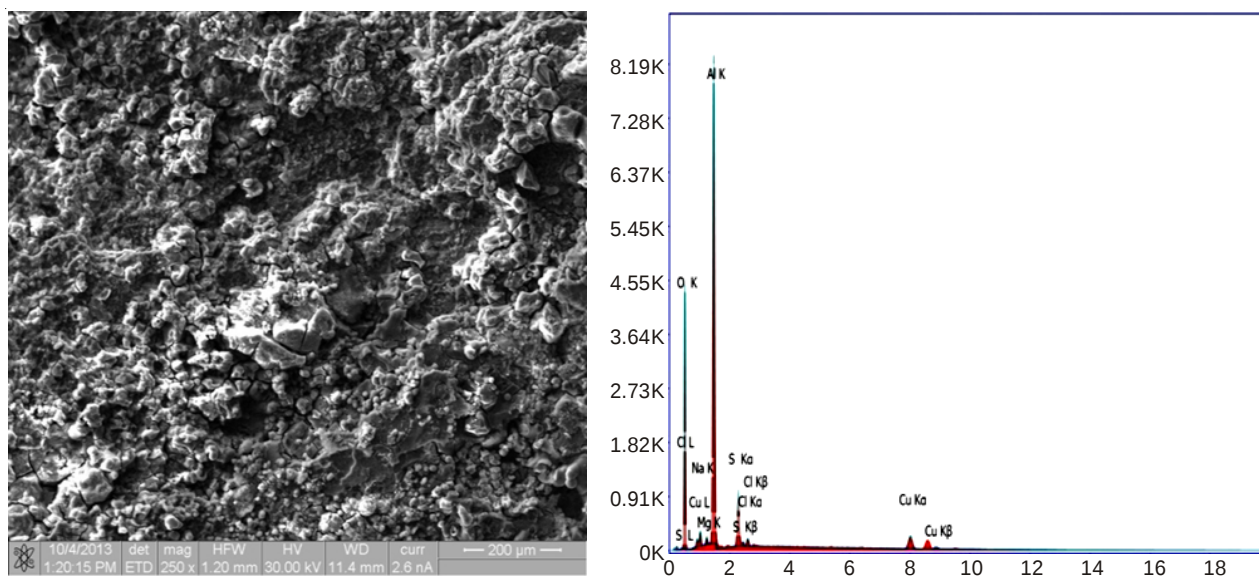
It can be seen in Figs. 22 and 23, those samples in the contaminated acid-chloride solution had the worst surface degradations including pits formation as a result of the chloride action on the reaction sites. This however correlates with the result obtained from the corrosion study for such samples in contaminated acid-chloride environments (Figs. 24 and 25).

Fig. 22. SEM/EDS spectra of corroded AA2036 in 0.5 M H<sub>2</sub>SO<sub>4</sub> + 3.5 NaCl solution

when immersed in the contaminated acid-chloride solution had the worst surface degradations including pits formation as a result of the chloride action on the reaction sites. The evidence of pitting corrosion was characterized when the samples when used in various contaminated acid-chloride environments.

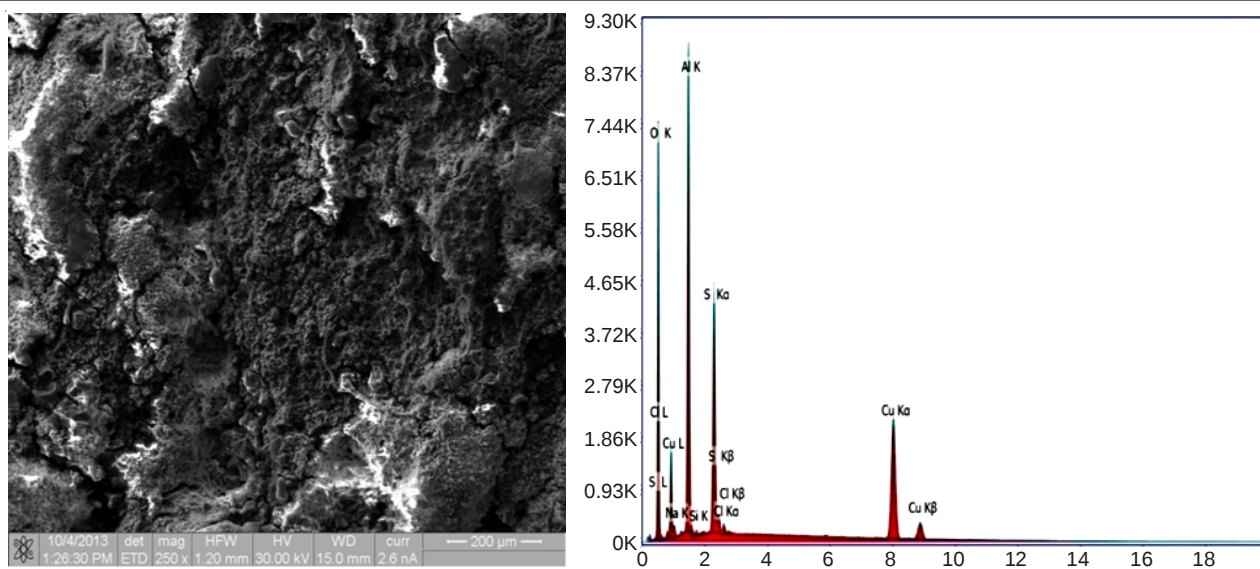
Fig. 23. SEM/EDS spectra of corroded AA7075-T651 in 0.5 M  $\text{H}_2\text{SO}_4$  + 3.5 NaCl solution

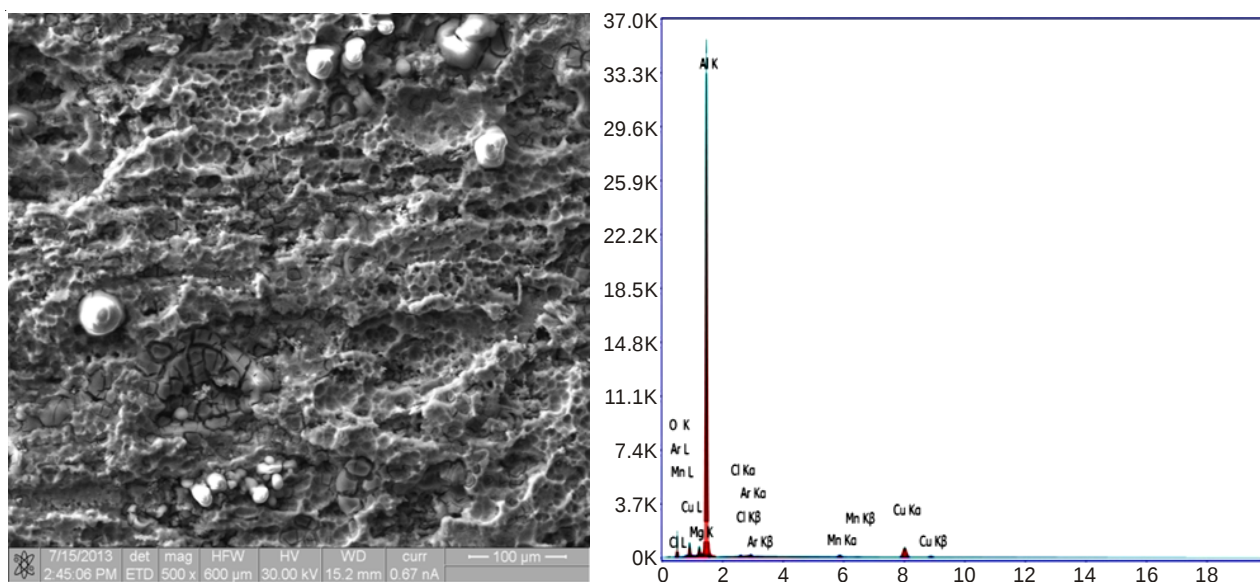
Fig. 24. SEM/EDS spectra of corroded AA2xxx in 0.5 M HCl + 3.5 % NaCl solution

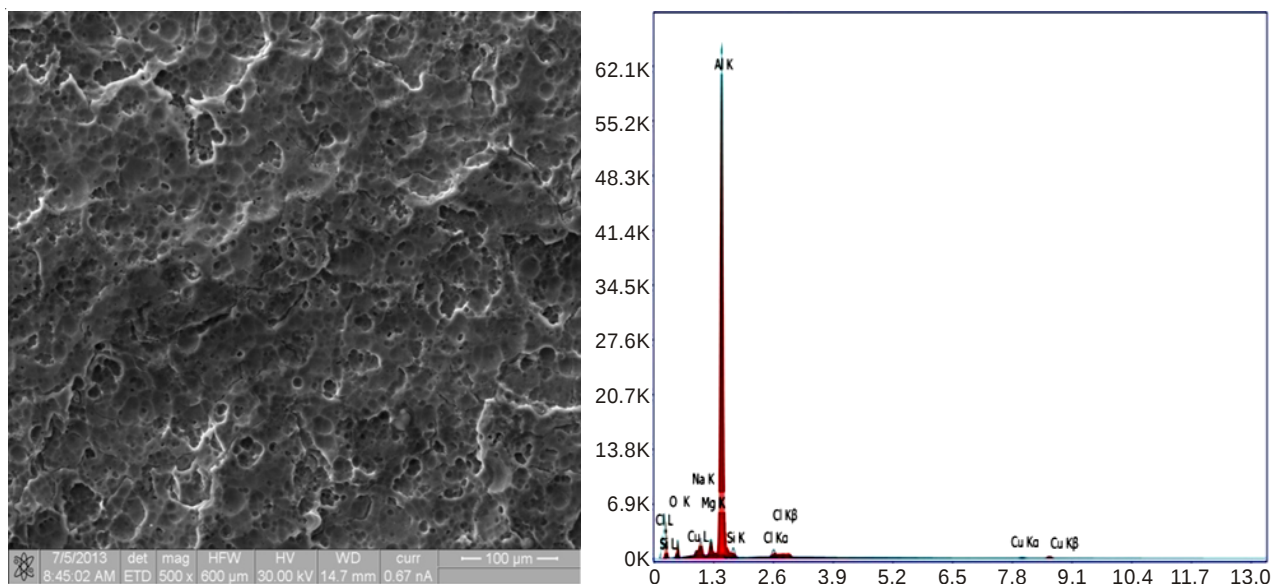
Fig. 25. SEM/EDS spectra of corroded AA7075-T651 in 0.5 M HCl + 3.5 % NaCl solution
